**Concrete Products Manufacturing Facility  
One Year Case Study  
Phoenix Arizona**

*Brad Kachurka, Account Manager*

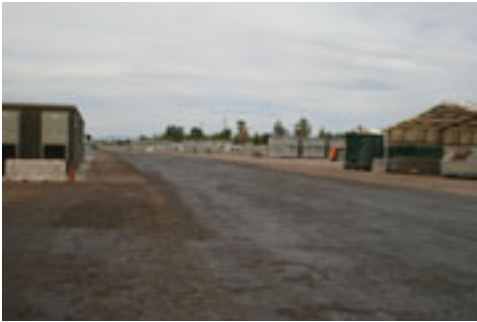
**Figure 4**  
Treated roadway intersection. Product is visible during the 4-5 week maintenance phase

Enssolutions offered a long term solution of treating roadways with a base surface of T.O.P. and maintenance coats on a periodic basis (depending on season and traffic wear). The initial maintenance applications occurred every 4-5 weeks but have now been reduced to every 6-7 weeks.

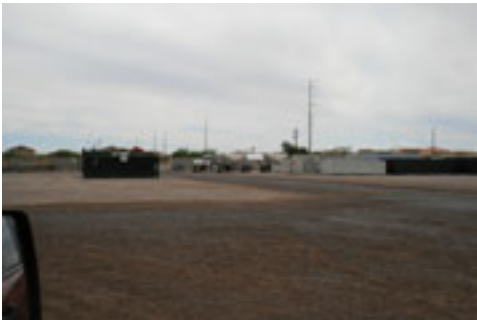
**Figure 5**  
Treated Intersection after three weeks. Notice some track on but T.O.P. is still binding surface.

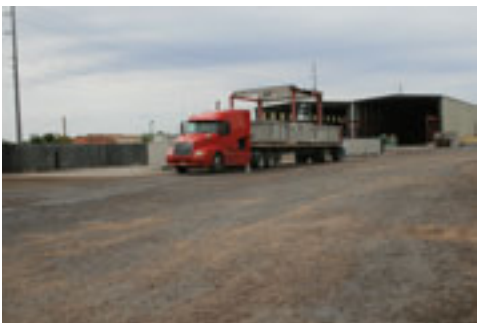
**Figure 6**  
Typically loaded truck - 40 - 60 trucks per day.

The customer is a manufacturer of specialized cement products weighing up to thirty tons. Their facility is located on fifteen acres with four acres of roadways. There is heavy fork-lift traffic on storage areas located adjacent to roadways. The customer has two main roads which ship between 40-60 semi-truck loads per day.

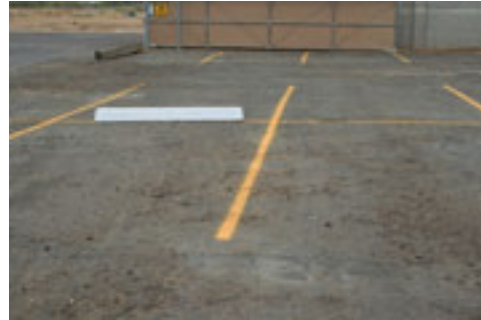
**Figure 7** Employee Parking lot treated and striped with no maintenance required for 6 month period.

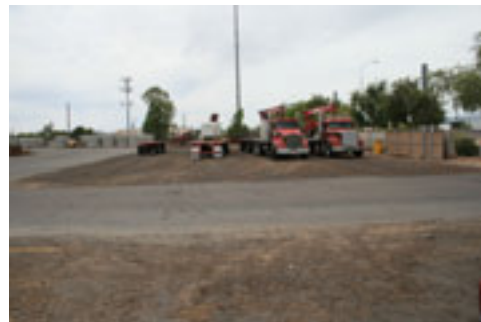
**Figure 8**  
Staging Area for loaded semi-trucks. Has high turnaround area.

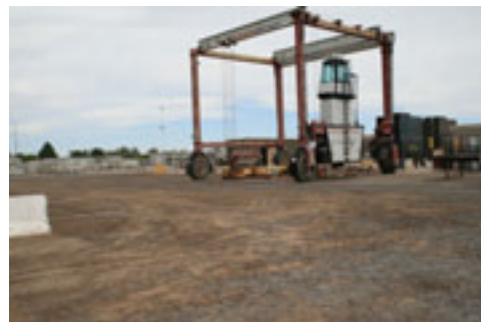
**Figure 9**  
Mobile Crane that carries typical 20-30T loads with infinite turning radius on off-road type tires.

1. Applied one coat of 5.6% solids over entire area.
2. Apply an additional coat to one acre of the project where mobile crane operates.
3. Maintenance applications are monitored until visible scuffing reaches 30-40% of the road surface.
